**Stratus Tool Technologies, LLC**

**Service Bulletin: SB-001**

**SUBJECT: OIL FILTER ADAPTER GASKETS**

**Applicability:** Continental aircraft engines having any of the following F&M or Stratus oil filter adapters installed in accordance with STCs SE09356SC, SE8409SW & SE10348SC.

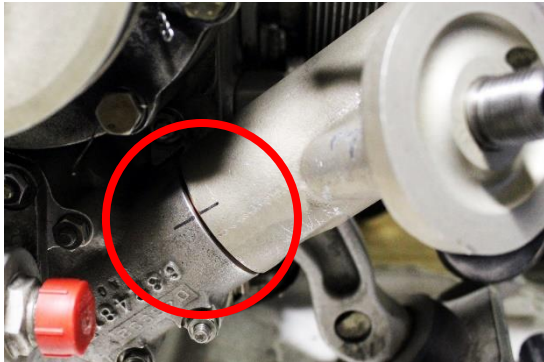
**Figure 1**

2. If NO leaks or seepage, however slight, or gasket damage, looseness or other discrepancies are discovered:
  - a. Use a fine point felt pen to make a match mark on the body and oil pump housing as shown in Figure 1. While standing beside the aircraft, grasp the oil filter and, using the filter as a lever (or 'handle'), apply 30 to 50 pounds of force in an attempt to rotate the filter body in a counter-clockwise direction around the oil transfer cylinder, see Figure 2. (Note: You are not trying to unscrew the filter itself. You are trying to make the body rotate about the oil transfer cylinder). Check the match marks for movement of the body. If ANY displacement of the match marks occurred and/or any movement of the body, the oil transfer cylinder, or both was detected, no matter how slight, proceed directly to Paragraph 3.

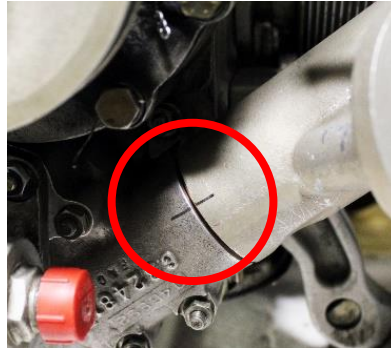
**Figure 5**

When the adapter is ready to be tightened, use a fine point felt pen to make a match mark on the body and oil pump housing as shown in Figure 5.

With the block in place, tighten the oil transfer cylinder to 65 ft/lbs torque. If the match marks misalign by more than 1/32 inch after tightening the oil transfer cylinder, i.e., the body has moved relative to the oil pump housing, remove the adapter assembly from the engine as previously described. Replace both gaskets with new gaskets and reinstall the adapter in accordance with the instructions

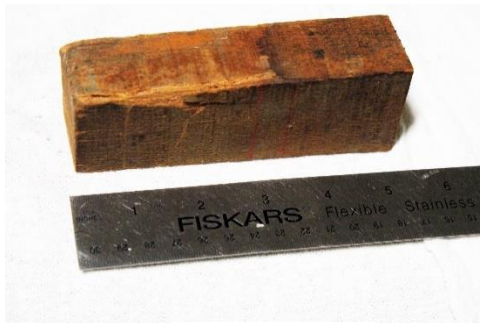
**Figure 6**

Fabricate a wooden block/wedge that will fit snugly between the oil filter mount flange and an adjacent structurally sound part of the engine or airframe that is competent to resist the turning forces encountered when tightening the oil transfer cylinder. Place the block so that as the oil transfer cylinder is tightened, the body cannot rotate with the oil transfer cylinder. See the exemplar arrangement in Figures 6 and 7.

Note: Because the oil filter adapters are used on many different aircraft, the block/wedge arrangement will be different in different aircraft.

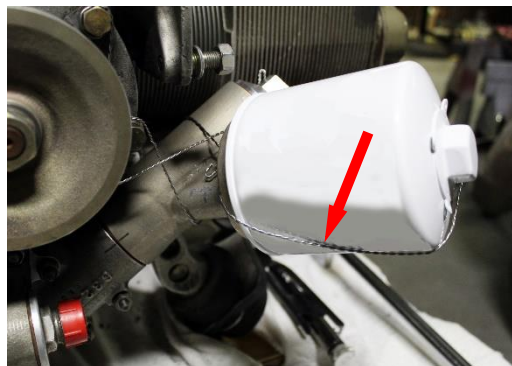
**Figure 10**

Install the oil filter. Tighten it to the torque recommended by the filter manufacturer. Safety-wire the filter to the safety-wire tab on the oil transfer cylinder, see Figure 10.

*Do not secure any safety-wire from the filter adapter or filter to the airframe.*
