Stratus Tool Technologies, LLC

Service Bulletin: SB-001 Rev C

SUBJECT: OIL FILTER ADAPTER GASKETS

Applicability: Continental aircraft engines having any of the following F&M or Stratus oil filter adapters installed in accordance with STCs SE09356SC, SE8409SW & SE10348SC.

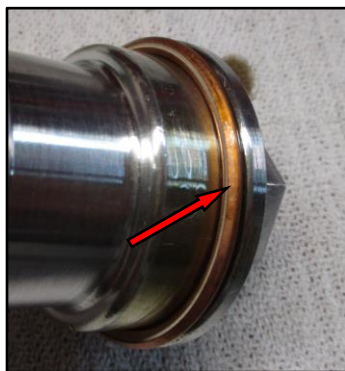
Figure 8

Lubricate the copper gasket with engine oil and install it onto the spool with the split side of the gasket turned away from the spool's flange, see Figure 8.

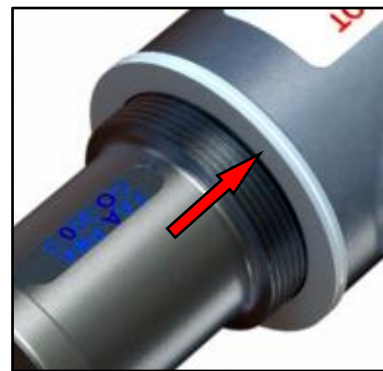
Figure 9

Slide the spool through the sleeve's bore and place the ST07 Lower Gasket (or second copper gasket) on the spool (the split side of the gasket away from the sleeve if using a second copper gasket), see Figure 9.

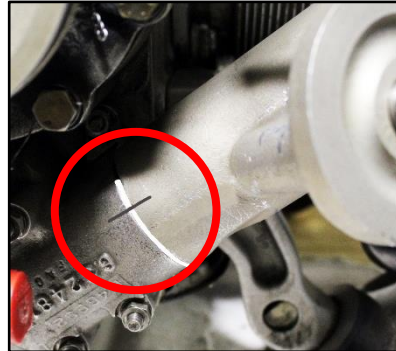
Figure 10

Thread the spool into the oil pump housing, when the adapter is ready to be tightened, use a fine point felt pen to make a match mark on the sleeve and oil pump housing as shown in Figure 10.

With the block in place, tighten the spool to 65 ft-lbs torque. If the match marks misalign by more than 1/32 inch after tightening the spool, i.e., the sleeve has moved relative to the oil pump housing, remove the adapter assembly from the engine as previously described. Replace both gaskets with new gaskets, relube the sleeve, spool, and top gasket with engine oil as shown in figures 6 and 7 and reinstall the adapter in accordance with the instructions contained in the Installation Instructions and ICA applicable to your model adapter.

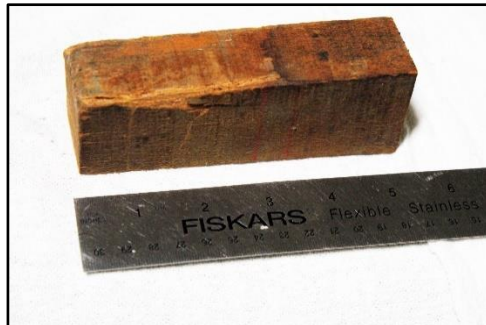
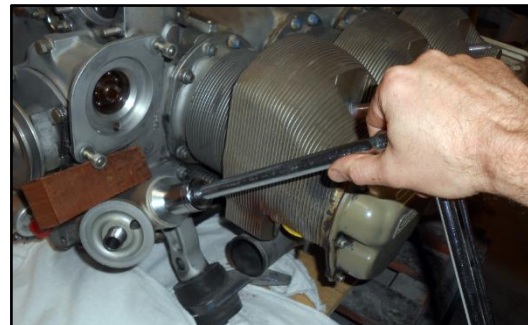
Figure 11

Fabricate a wooden block/wedge that will fit snugly between the oil filter mount flange and an adjacent structurally sound part of the engine or airframe that is competent to resist the turning forces encountered when tightening the spool. Place the block so that as the spool is tightened, the sleeve cannot rotate with the spool. See the exemplar arrangement in Figures 11 and 12.

Note: Because the oil filter adapters are used on many different aircraft, the block/wedge arrangement will be different in different aircraft.

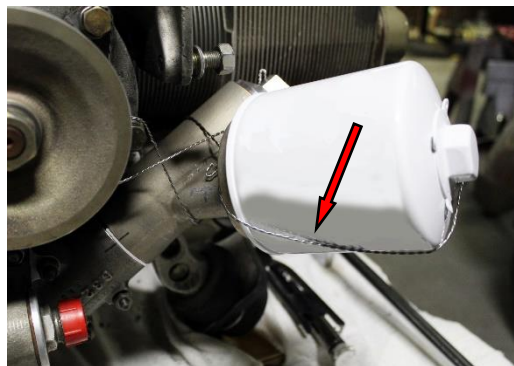
Figure 15

Install the oil filter. Tighten it to the torque recommended by the filter manufacturer. Safety-wire the filter to the safety-wire tab on the sleeve, see Figure 15.

Do not secure any safety-wire from the filter adapter or filter to the airframe.
